[BNF Consulting, Inc. | www.askBNF.com](http://www.askBNF.com)
152 Route 202, #404, Lincolndale, NY 10540-0404

RE: Lead-Based Paint (LBP) Survey at [Redacted]

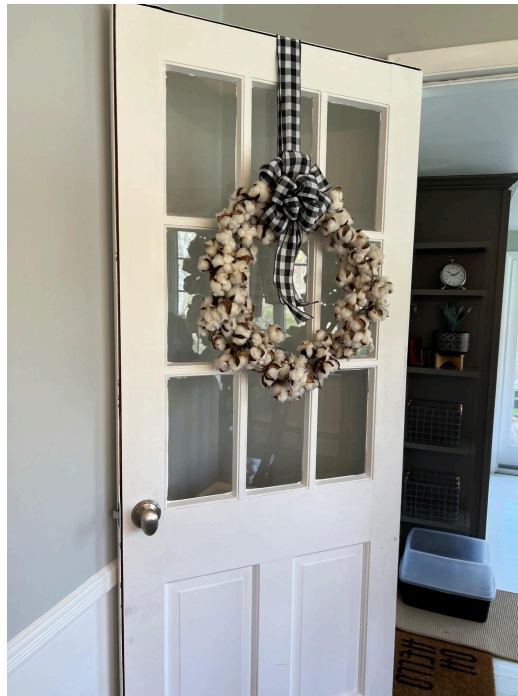
Figure 1. Door to the mudroom

- Lower Level and Upper Level: Detected no LBP in the various elements such as doors, window trims/sills, walls, ceilings, and moldings as shown in the Appendix A, Site Photos 1 - 2.
- Exterior: Most areas are LBP including doors, walls, trim, and deck posts as shown in the Appendix A, Site Photos 3.

| Location | Components/Areas | XRF Readings* | | | | Limit |
|---|---|---|---|---|---|---|
| Mudroom | Door | 0.7 | | | | 1.0 |

- It is recommended to do lead testing for water and soil of the property.
- While New York State and US EPA define 1.0 mg/cm² as a LBP, New York City defines LBP at a level of 0.5 mg/cm², so any components between 0.5 and 1.0, for example, original doors and walls as shown in Site Photos 1-2 of Appendix A should be closely monitored and considered as a potential lead paint dust hazard.

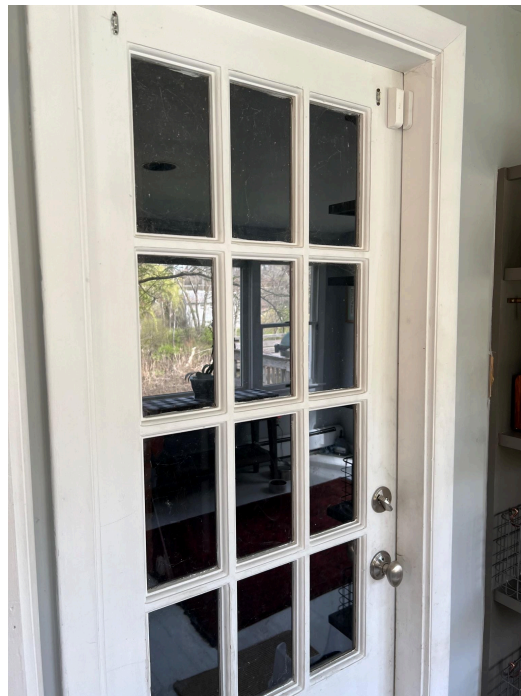
Figure 2. Door to the garage

| Location | Components/Areas | XRF Readings* | | | | Limit |
|---|---|---|---|---|---|---|
| | Door to garage | 0.6 | | | | 1.0 |

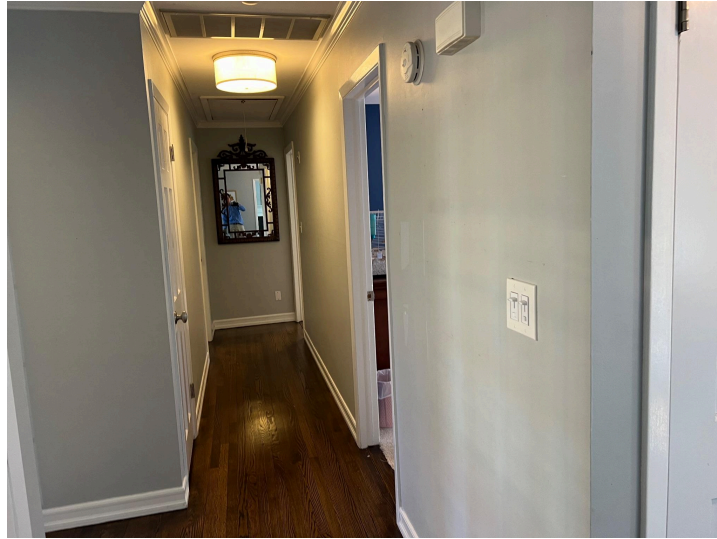
Figure 3. Hallway

| Location | Components/Areas | XRF Readings* | | | | Limit |
|---|---|---|---|---|---|---|
| | Wall Hallway | 0.9 | 0 | 0 | 0 | 1.0 |

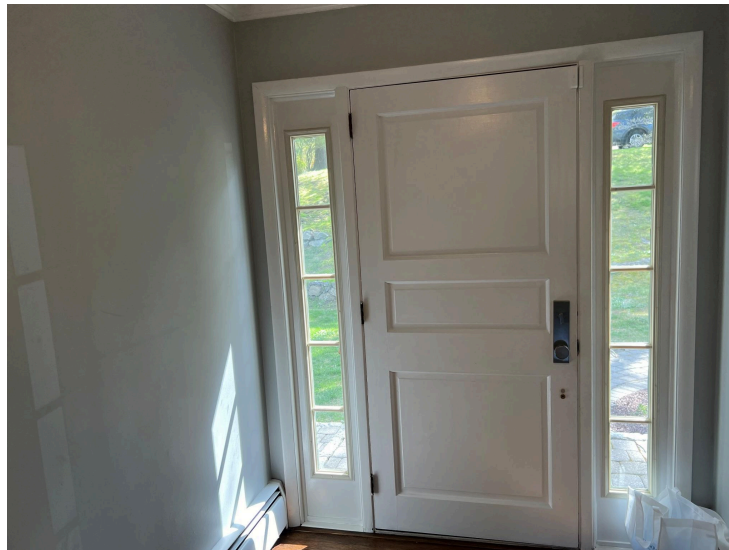
Figure 4. Entrance

| Location | Components/Areas | XRF Readings* | | | | Limit |
|---|---|---|---|---|---|---|
| Entry Hallway | Door entry | 0.7 | | | | 1.0 |
| | Wall entry | 0.6 | 0 | 0 | 0.7 | 1.0 |

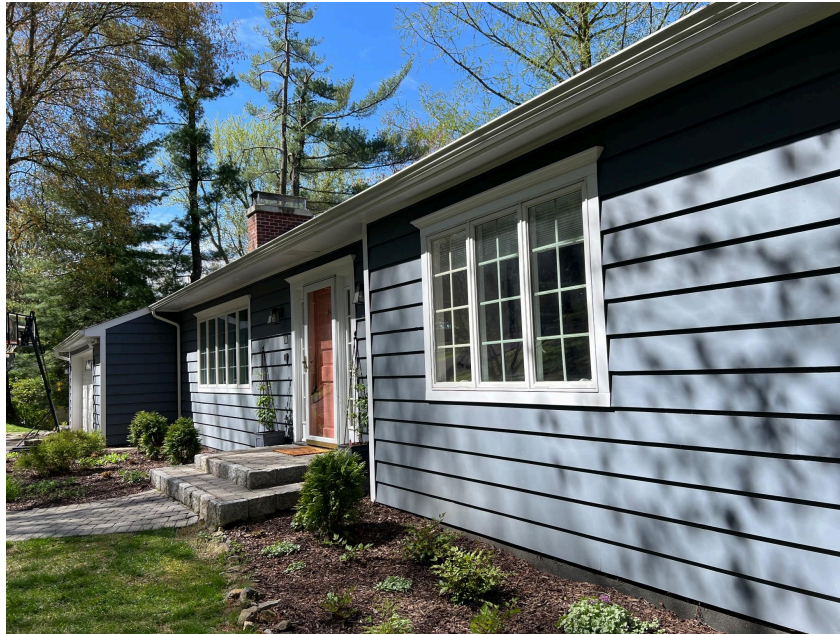
Figure 5. Wall, trim (front)

| Location | Components/Areas | XRF Readings* | | | | Limit |
|---|---|---|---|---|---|---|
| Exterior | Wall front | 1.7 | 1.1 | 2.3 | | 1.0 |
| | Wall trim | 0.6 | 2.3 | | | 1.0 |

- Interior and Exterior: Repainting, paint removal on high-friction and impact surfaces, and component replacement with non-lead alternatives like vinyl windows.
- Exterior Specific: Installation of non-lead-containing materials such as vinyl or aluminum siding, comprehensive material replacement, and specialized paint removal techniques on deteriorated exterior surfaces.

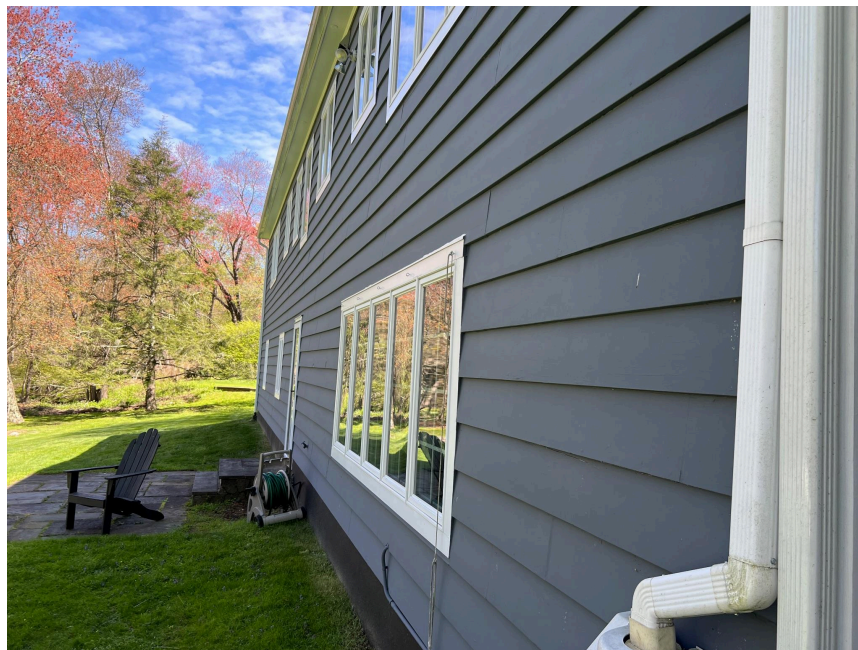
Figure 6. Wall, trim (rear)

| Location | Components/Areas | XRF Readings* | | | | Limit |
|---|---|---|---|---|---|---|
| | Wall rear | 1.8 | 1.8 | | | 1.0 |
